St Albans Christmas Lights locations - November 2017

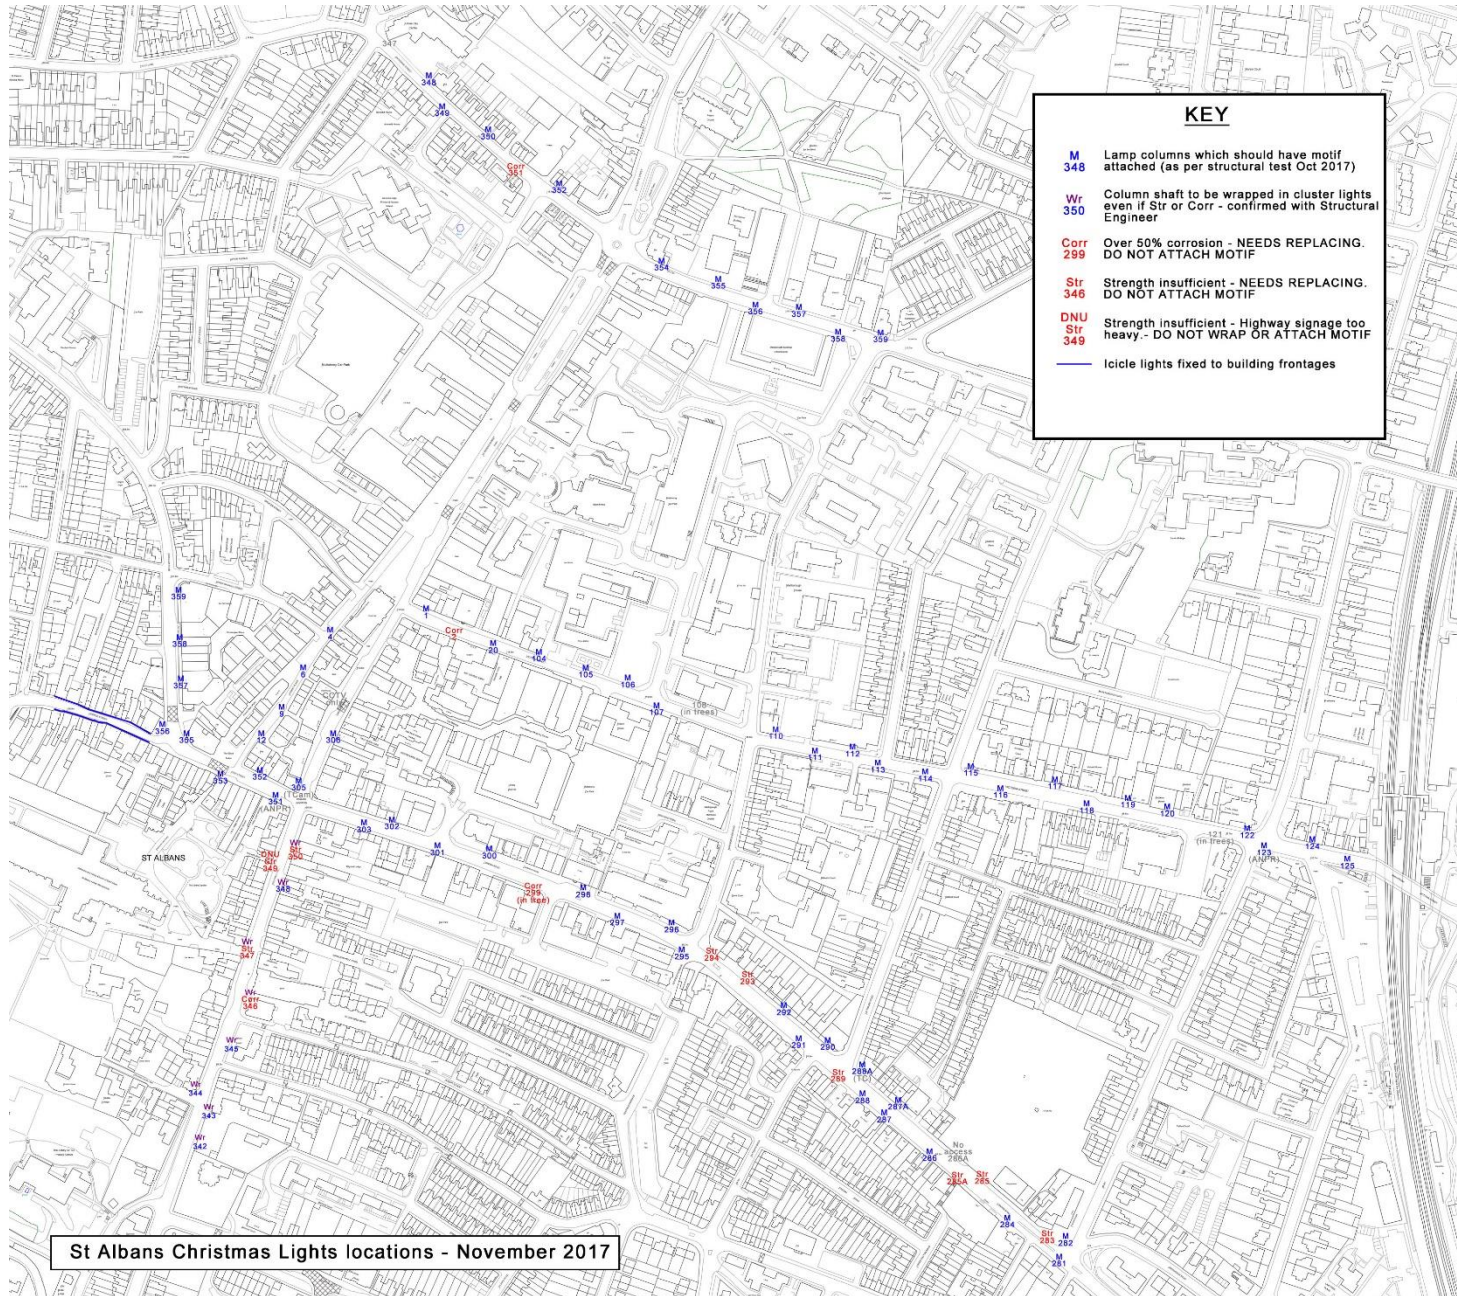
M 348	Lamp columns which should have motif attached (as per structural test Oct 2017)
Wr 350	Column shaft to be wrapped in cluster lights even if Str or Corr - confirmed with Structural Engineer
Corr 299	Over 50% corrosion - NEEDS REPLACING. DO NOT ATTACH MOTIF
Str 346	Strength insufficient - NEEDS REPLACING. DO NOT ATTACH MOTIF
DNU Str 349	Strength insufficient - Highway signage too heavy - DO NOT WRAP OR ATTACH MOTIF

Icicle lights fixed to building frontages
