Structural Defect Report Highway Electrical Equipment

St Albans City And District Council : St Albans

Area: SIT & BSEN40 2014/2015

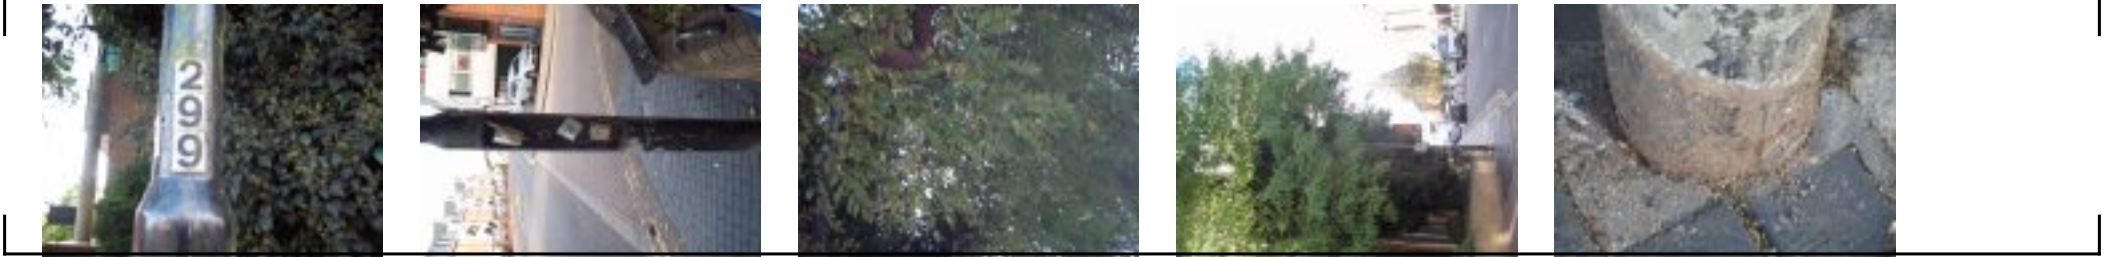
Equipment No: 19	Unit No: 299	Unit Type: STREET LIGHT	Current Structural Status: R
Elevation: 101m	Avg Wind Speed: 10.14kph

Defect Type: S17	LOR: R	Location: OPPOSITE DOMINOS/BLUE ARROW	
Defect Desc: STRUCTURAL - LOSS OF THICKNESS IN ROOT SECTION - 54% LOSS			
Defect Code Desc: Probable Danger			
Date Reported: 23/10/2014	Reported By: STEVENS, S	Date Rectified:	Rectified By:
Responsible: PRIVATE

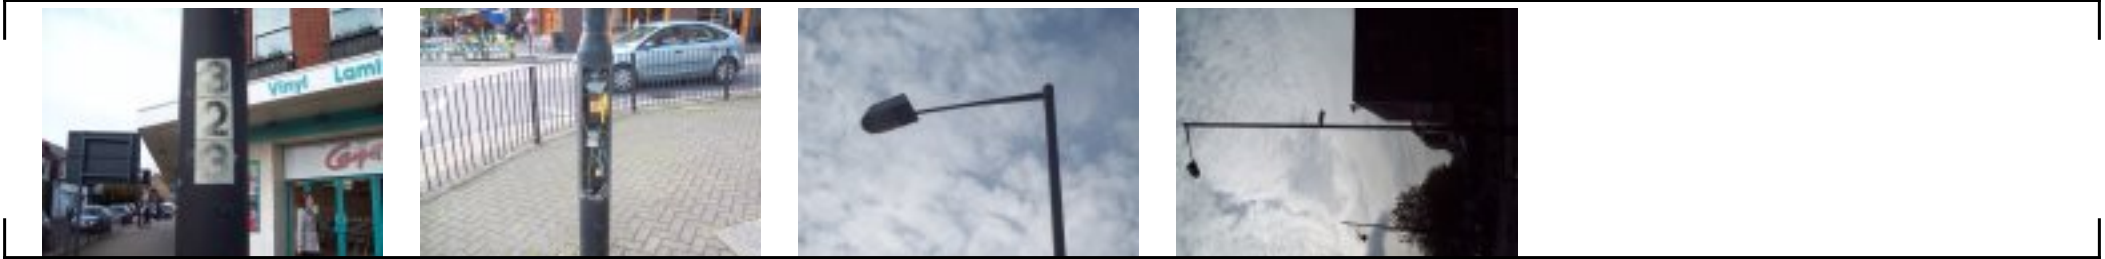
Equipment No: 73	Unit No: 323	Unit Type: STREET LIGHT	Current Structural Status: R
Elevation: 121m	Avg Wind Speed: 10.3kph

Defect Type: S14	LOR: R	Location: ROUNDABOUT OS CARPET RIGHT	
Defect Desc: STRUCTURAL - BASE COMPARTMENT, 60% LOSS			
Defect Code Desc: Probable Danger			
Date Reported: 23/10/2014	Reported By: STEVENS, S	Date Rectified:	Rectified By:
Responsible: PRIVATE

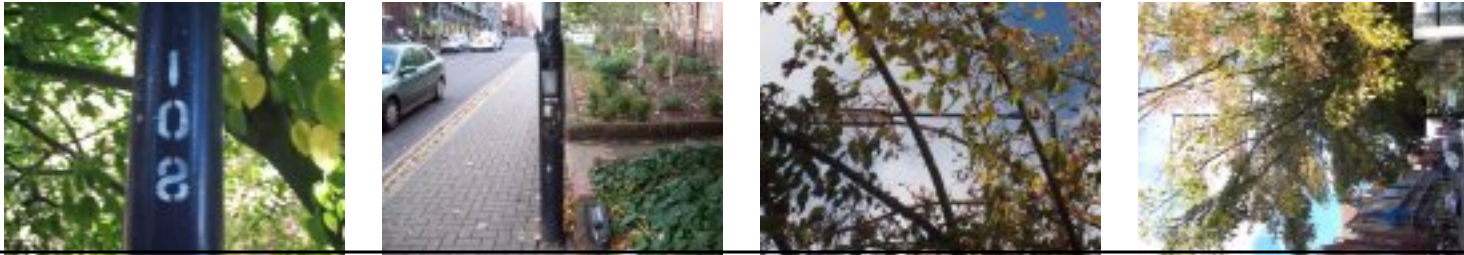
Equipment No: 35	Unit No: 108	Unit Type: STREET LIGHT	Current Structural Status: R
Elevation: 112m	Avg Wind Speed: 10.14kph

Defect Type: S32 LOR: R Location: OUTSIDE VALUATION OFFICE

Defect Desc: DAMAGED LANTERN BOWL

Defect Code Desc: Probable Danger

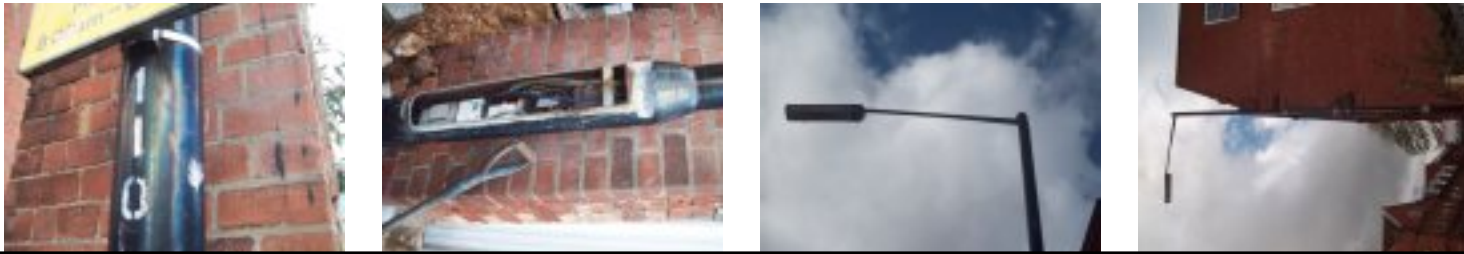
Equipment No: 36	Unit No: 110	Unit Type: STREET LIGHT	Current Structural Status: R
Elevation: 107m	Avg Wind Speed: 10.14kph

Defect Type: S32 LOR: R Location: OUTSIDE BUILDING PROJECT

Defect Desc: DAMAGED LANTERN BOWL

Defect Code Desc: Probable Danger
